## Assessment of Erosion and Soil Erosion Processes – a Case Study from the Northern Ethiopian Highland

*Stefan Thiemann<sup>1</sup>, Brigitta Schütt<sup>2</sup> and Gerd Förch<sup>1</sup>*

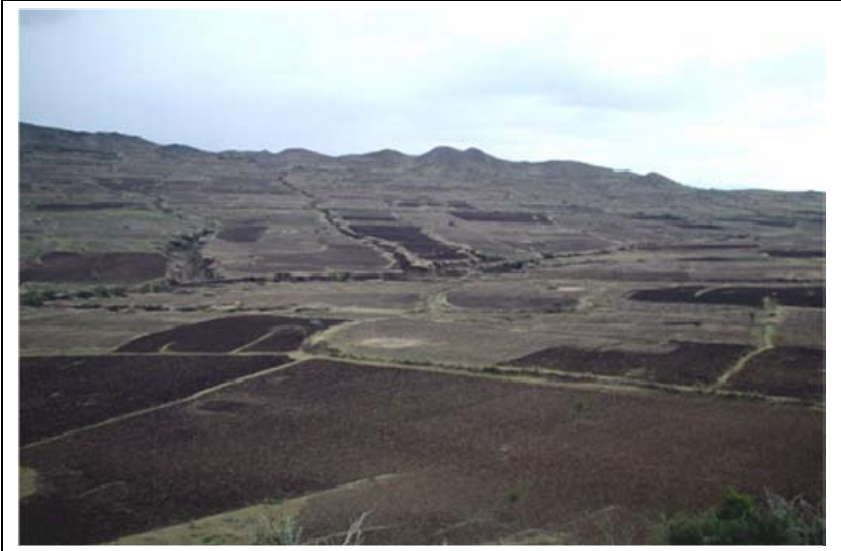
Figure 1: Development of Gullies in the Dana Catchment

U-shaped channels in the basin centre, once developed from gullies, currently have a total extent of approx. 6.5km (total channel length). The development of these u-shaped channels – that makeup a channel network – started to develop about 30 years ago in the area where the *Dana* Dam is located today. As gully development coincided with deforestation of hill slopes and increasing tillage, it can be concluded that gully development was caused by increased surface runoff as a consequence of changes in vegetation cover and land management.

It should be emphasised that these younger gully-systems are all located in the colluvial and alluvial zones below settlement areas. Their development is mostly caused by high rates of surface runoff generated on the poorly vegetated and highly compacted areas around the settlements. Moreover, along footpaths this surface runoff is channelled and, thus, can develop linear erosion forces. In sum, development of secondary gullies does not occur below headwater

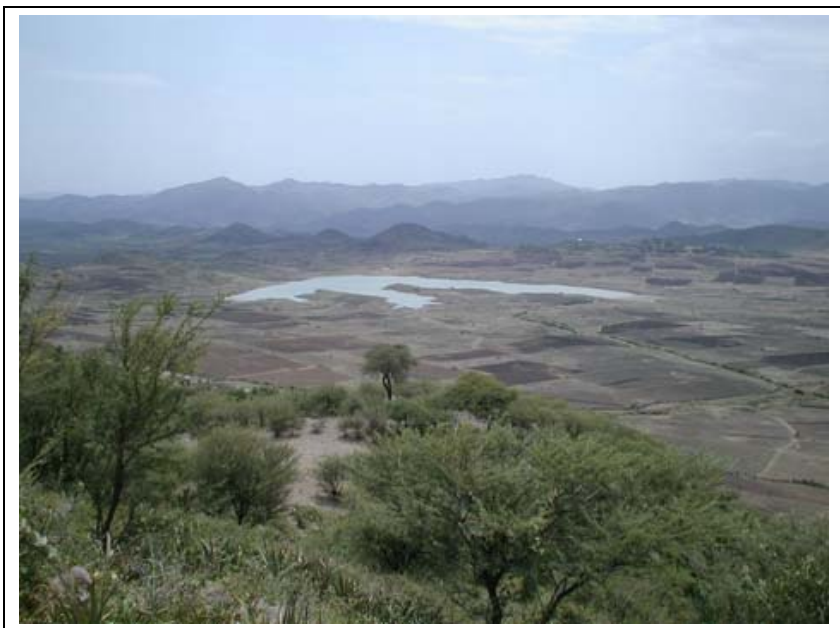
Figure 2: Colluvial / alluvial zone, dam and major channels

In particular, a high level of gully formation processes with a development of badland areas occurs in the immediate neighbourhood of the dam site. The reservoir (Figure 2) is used by people and livestock as a source for drinking and bathing water. They cause disturbance of soil structures and soil compaction along the shore of the reservoir. Due to the compaction rate infiltration decreases and surface runoff increases. The disturbed soil structure results in an increased erodibility of the soil. Overall, it can be concluded that the severe badlands around the *Dana* Dam site developed in consequence of the retaining of the *Dana* River during the last three years.

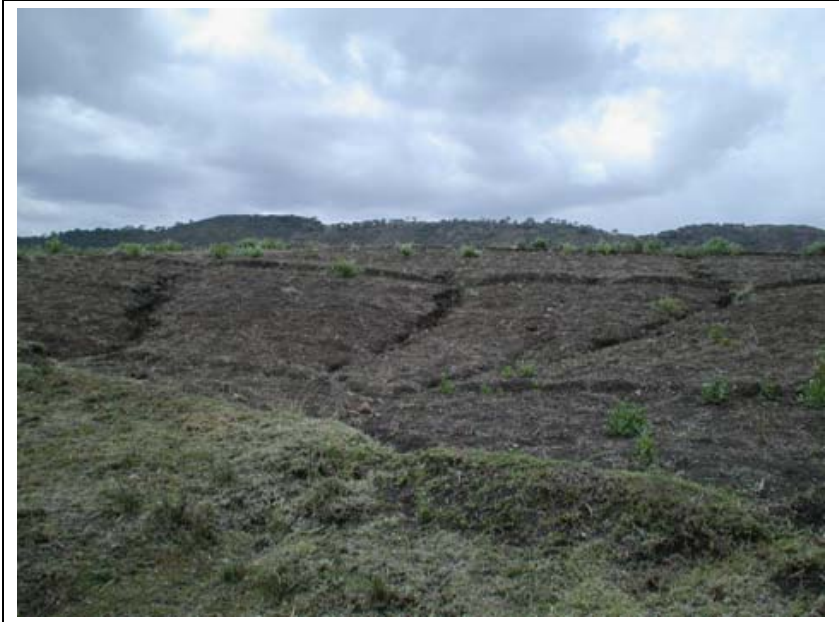
Figure 4: Rill erosion north of *Adisukebele*

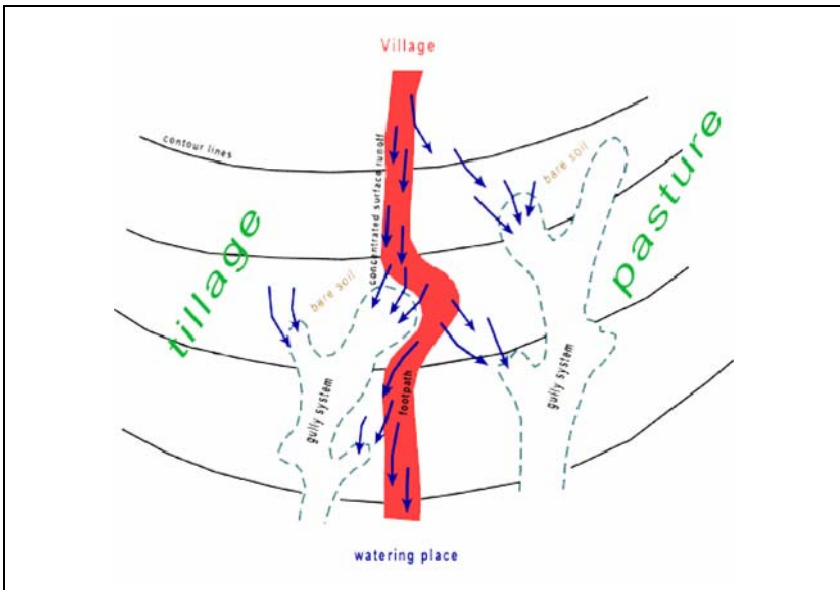
Figure 5: Typical interaction of footpaths and generation of gully-systems:

Footpath perpendicular to contour lines (shortest way from village to watering place)

Tillage and pasture area wide coming along with bare soil (e.g. overgrazing)

Soil compaction on footpath associated with concentration of surface runoff

Gully-heads closed to footpath

In contrast to these area-wide soil erosion processes – that only vary in intensity – gully erosion predominantly occurs in the immediate neighbourhood of footpaths running perpendicular to contours. Almost all gully-systems recorded run along footpaths. The impact of channelled runoff along footpaths is alarming and intensified by the heavy soil compaction and by poor infiltration rates (see Fig. 5).

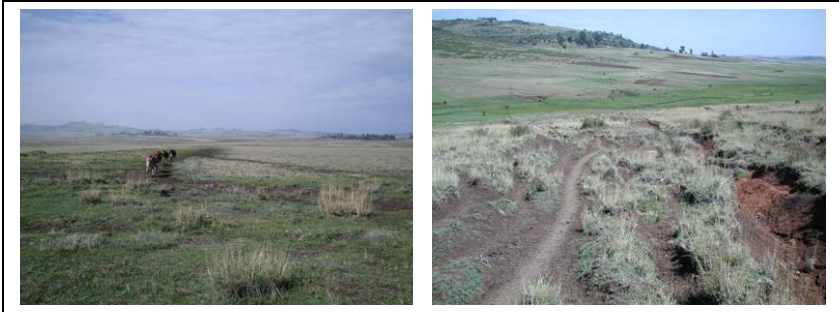
Figure 6: Cattle tread

Figure 7: Gully parallel to footpath

Damage resulting from soil erosion in the *Beriti* watershed is predominantly caused by cattle tread (Fig. 6), particularly around settlements, along footpaths and parallel to the road, as well as below the settlements along the direct path to the watering place (Fig. 7). As a result, damage caused by soil erosion due to soil compaction can be attributed to the intense movement of livestock and people and frequently leads to the development of badlands.

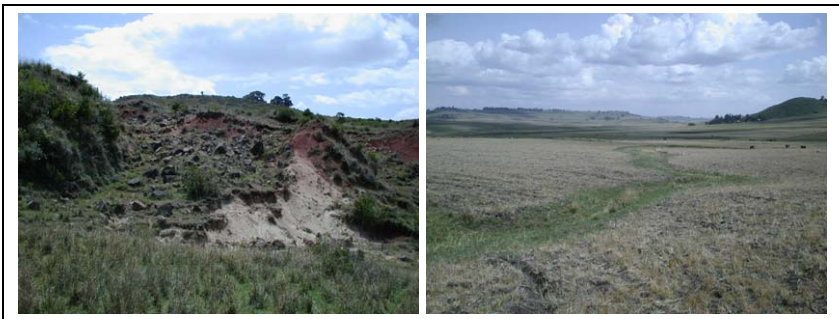
Figure 8: Badland development caused by cattle tread

Figure 9: Grassed waterway
